## GENERAL INFORMATION

| Product Name | Wall pack |
| Service performed | FRI |

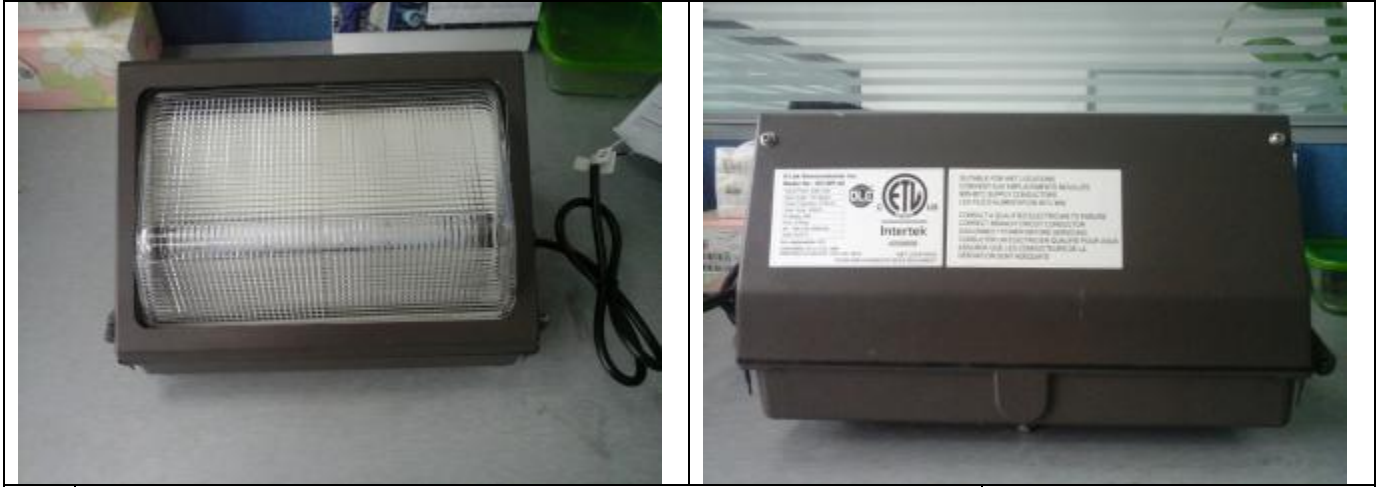
| B1 | Style Conformity | Pending |

| Remark: No gold seal samples and specification were available for compare when inspection. | | |

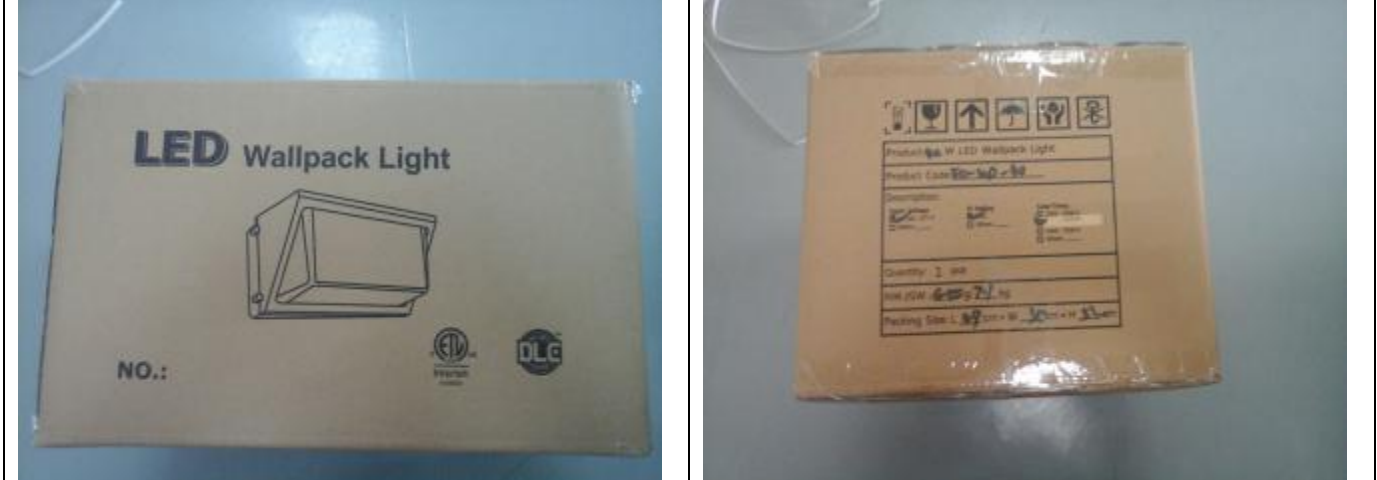
| C2 | Shipping Marks Conformity | Pending |

Remarks: The shipping marks of carton were not provided for compare when inspection.

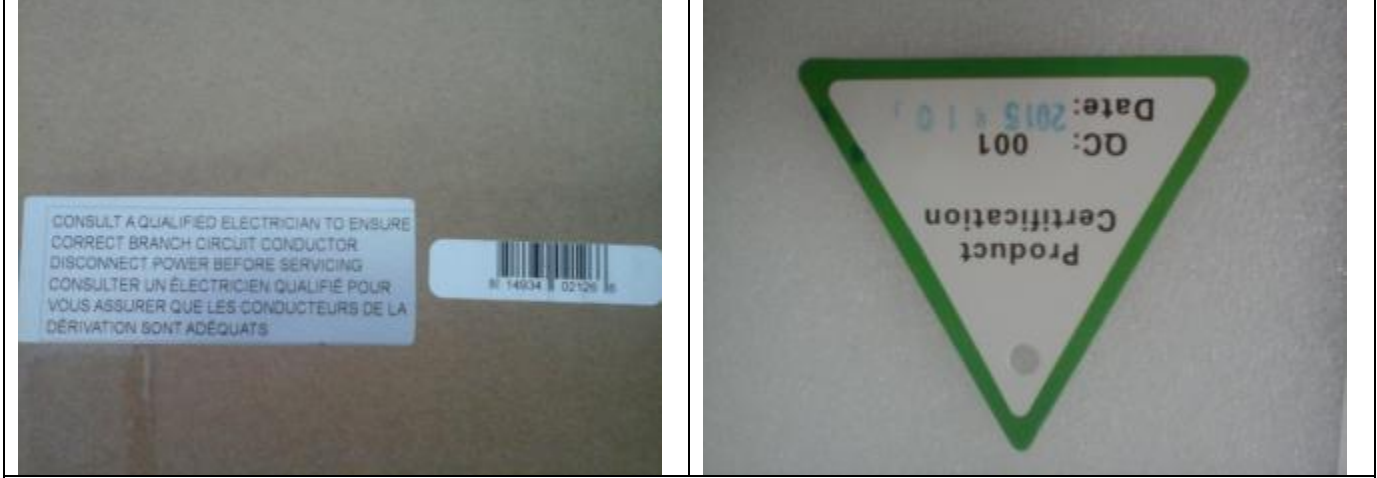
| C3 | Labeling Conformity | Pending |

Remarks: The label and marks of carton were not provided for compare when inspection.

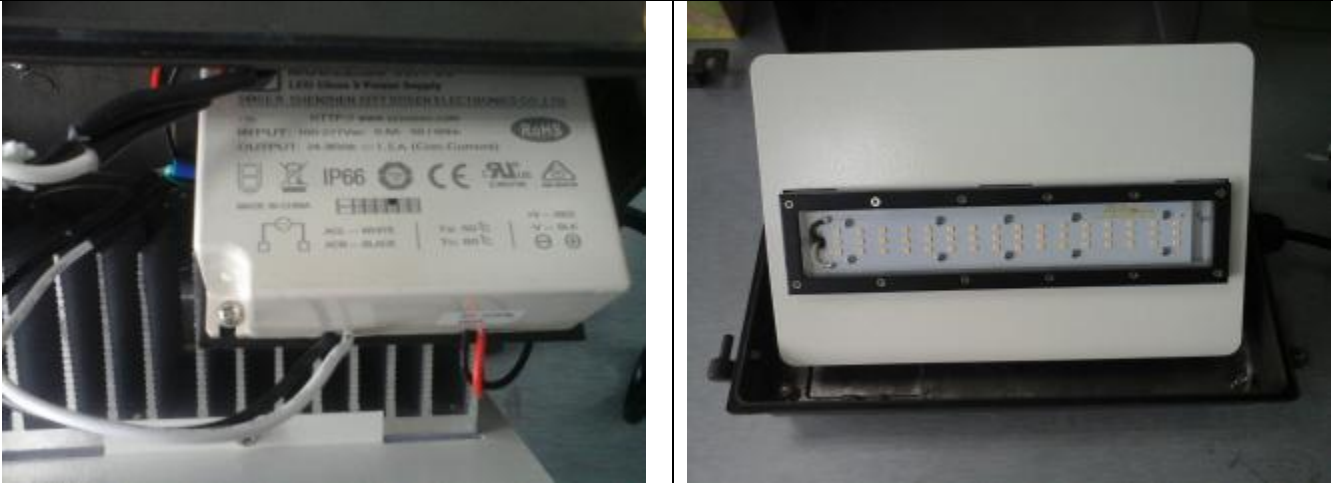
| D6 | Internal workmanship and critical component check | check internal construction and components. the wire ways should be free from sharp edge or heating or moving to cause insulation damaged, internal connection should be security fixing and the component should be complied with requirement according with CDF or (critical component list) CCL | 2 | Conform |

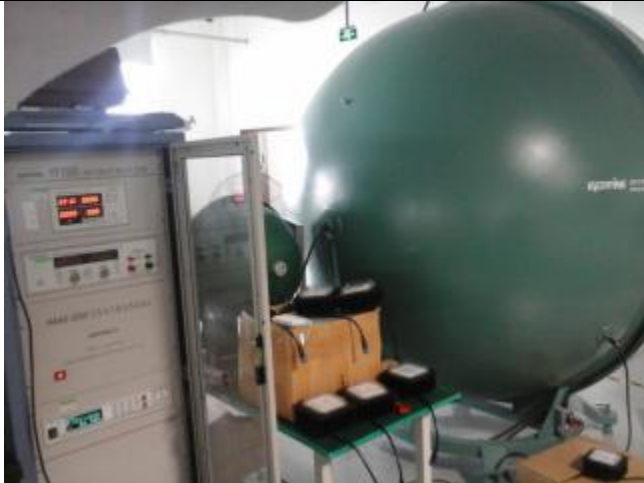
Lighting character spectrum test

| D8 | Bulb lighting character spectrum test | When power on the unit at rated voltage, and then check the range of the bulb lighting character spectrum as intend. It should be complied with specification required. | 2 | Conform |

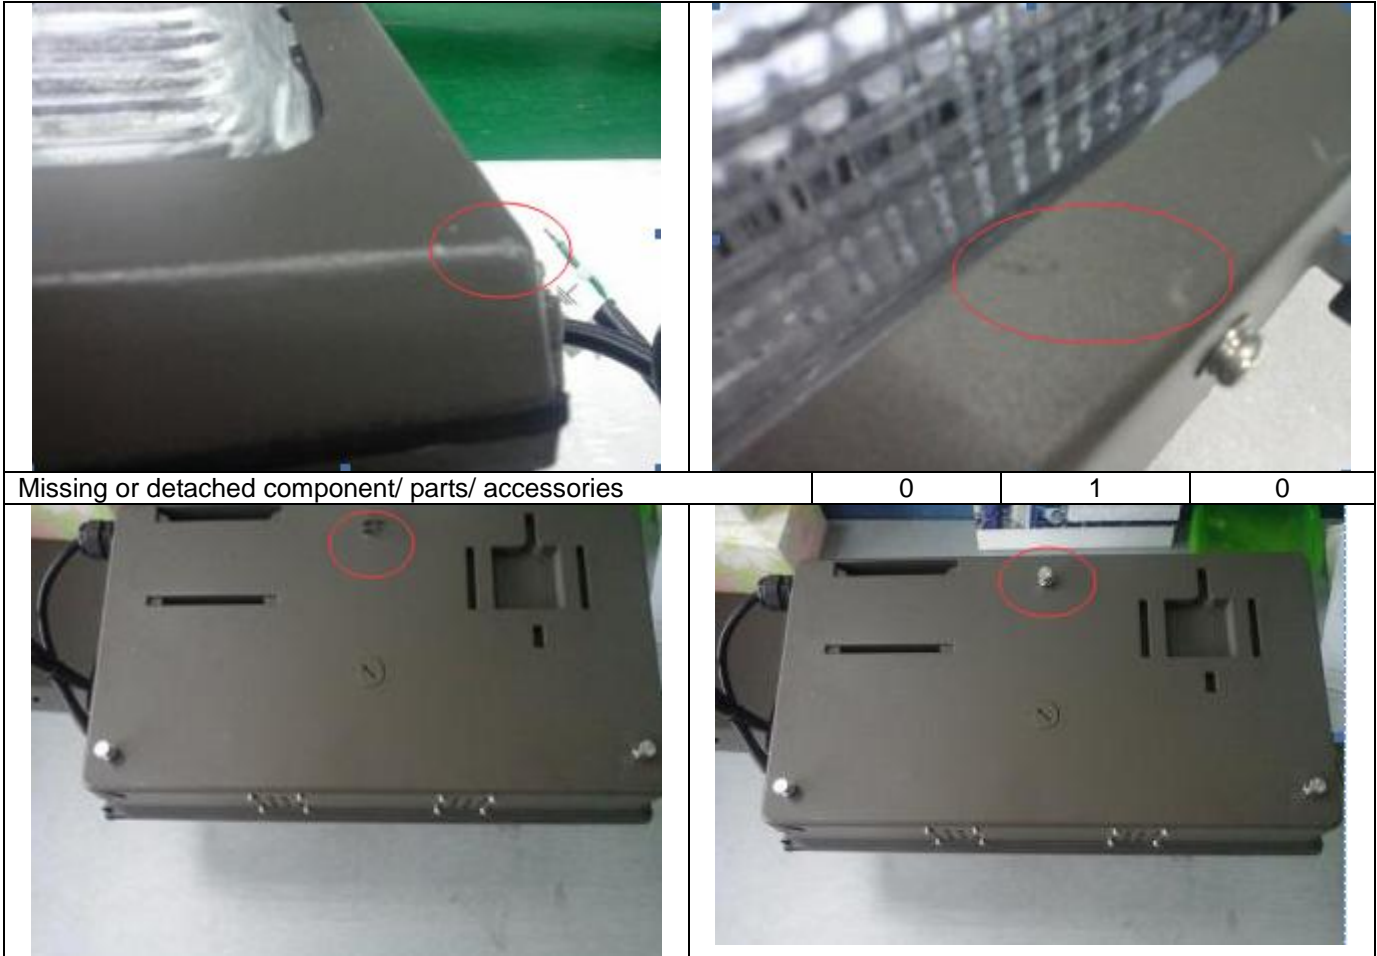
| For Item: 123456 Sample size:80 | | | |
|--|---|---|---|
| Poor paint, printing, coating issue: such as peel off, stains, drip, overflow, blister, pits, discoloration etc. | 0 | 0 | 2 |

| Missing or detached component/ parts/ accessories | 0 | 1 | 0 |
